BALAUSTINE

(in the Radisson Hotel Graz)

ACCESSIBILITY

Status: July 2024, all information without guarantee

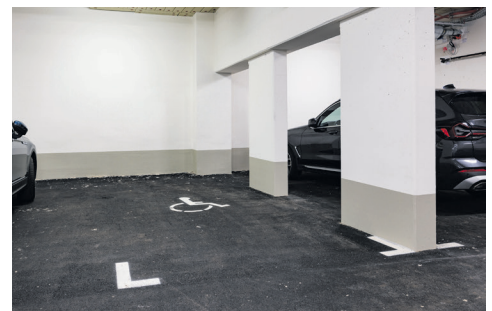
Barrier-free car park

- 1 disabled parking space in the hotel's own underground car park
- with floor markings, near the entrance to the hotel
- on a level surface, at right angles to the carriageway; 350 cm wide
- Access to garage at least 3 m wide, barrier opens automatically (controls for opening are at a height of 110 cm, accessible from a wheelchair or car)
- **No emergency call available**
- Path to hotel entrance suitable for wheelchairs (asphalt), level
- **No tactile floor guidance system to the entrance**

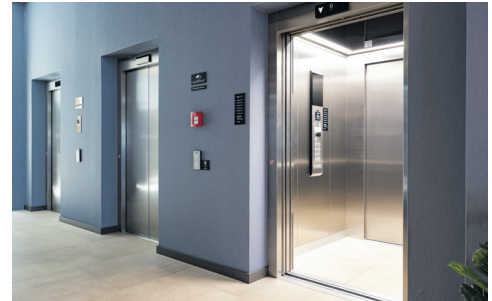
Lift

- **A hotel room card is required to use the lift!**
- Accessible without thresholds, movement area in front of entrance and exit at least 150 x 150 cm
- Clear door width at least 90 cm, light barriers at max. 100 cm

- Car size 140 x 140 cm
- Push buttons in the immediate vicinity of the lift door, at standard height (inside and outside)
- tactile push buttons (inside and outside) in raised lettering, inside also in Braille

- Push button for the building exit is highlighted
- Pressing the push buttons (inside and outside) is audibly confirmed, **but not visibly**
- **No acoustic signal when the lift arrives, no audible announcement in the lift**

- Handrail available, at standard height
- Mirror available, **but not opposite the lift door**
- Emergency call button present, at standard height; pressing the emergency call button **is not visibly confirmed**

- Position indicator in the lift car at standard height

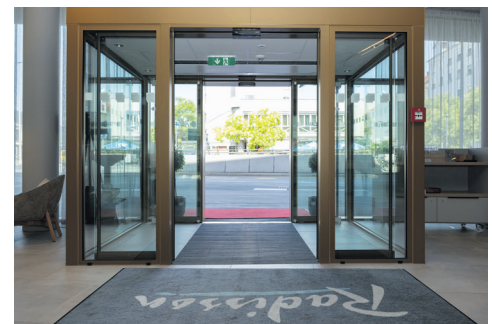
- Access to the hotel is level and without thresholds, free of obstacles
- Path at least 150 cm wide, **not covered**
- The barrier-free entrance is the main entrance
- Entrance covered, free of obstacles, level
- Automatic sliding glass door, opens early and closes with a time delay
- Door **not marked with sufficient contrast, door opening side not labelled**
- Clear width 140 cm, no threshold
- Vestibule: approach area of at least 150 cm in diameter on both sides of the door
- Grating and dirt-trapping mat easily accessible
- **No tactile floor guidance system to the entrance**

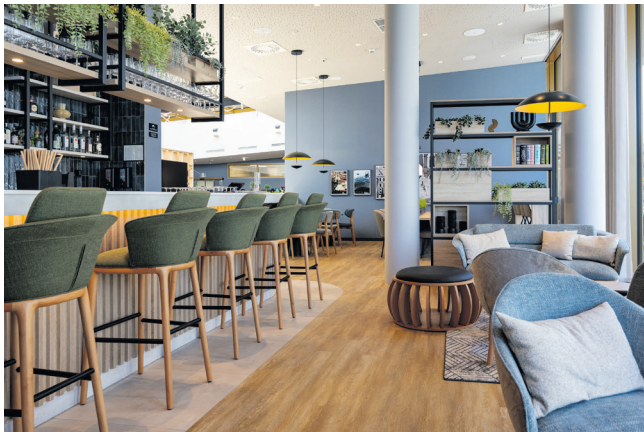
Bar

- Seating 46 - 50 cm high, with sturdy armrests and backrests
- Breakfast: buffet with service, food is within reach of 40 - 70 cm and available at a height of 90 - 110 cm
- bar: **counter 90 - 110 cm high, no lowered space of 85 cm, no under-counter wheelchair access**, 150 x 150 cm manoeuvring space available in front of the counter
- Straws are available on request
- No carpets in the restaurant area, but **upholstered furniture and curtains**
- Staff are aware of the composition of the food
- There are also tables with glare-free lighting and tables with sufficient noise reduction
- **no children's chairs available**

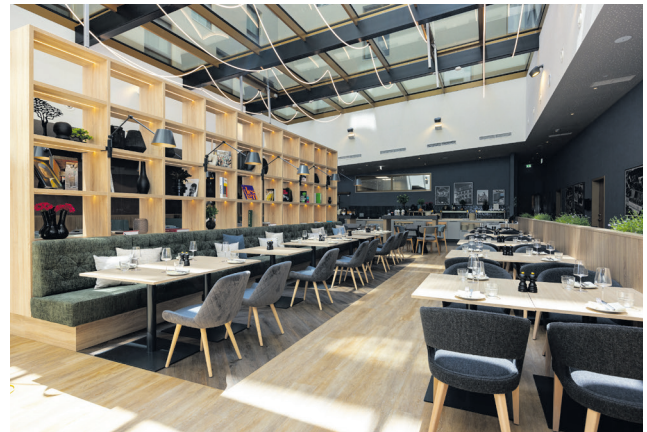
Restaurant

- Access completely level, no thresholds
- No cloakroom available
- Passage widths from main aisles at least 100 cm, from cross aisles at least 70 cm
- under-table wheelchair access (min. 80 cm wide, 70 cm high, 60 cm deep), table height max. 85 cm

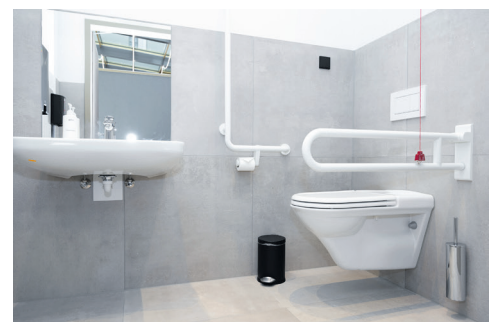
General barrier-free WC

- Accessible without thresholds
- Separately arranged (unisex)
- Movement area of 150 x 150 cm available in the WC room

- hinged door, clear passage width at least 80 cm, no threshold
- Door opens outwards, can be unlocked from the outside in an emergency
- Easy to open, **door closer**
- Approach area on opening side min. 200 x 150 cm, on closing side min. 150 x 120 cm
- There is an approach area of at least 50 cm on both sides of the door next to the lever handle
- Lever handle at standard height, no turn, knob or shell handle, no additional horizontal pull handle

- **less than 120 x 120 cm manoeuvring space in front of the toilet bowl** (washbasin in the way)
- WC can be approached from the right, at least 90 cm space on this side

- WC at a **height of 52 cm** (standard 46 - 48 cm), **no backrest available**
- Distance from the front edge of the WC to the rear wall to be approached 68 cm

- Horizontal grab rails on both sides, foldable on the right, at standard height
- **Distance between the grab rails 73 cm** (standard 65 - 70 cm)
- Additional vertical grab rail

- grab rails protrude at least 15 cm beyond the front edge of the WC
- Folded up handle does not protrude more than 20 cm into the room
- Folding support handle easy to operate, securely fastened to the wall

- WC flush at standard height, WC paper accessible from a seated position
- Emergency bell can be reached from the WC while seated, **cannot be reached from the floor at a height of 35 cm**

- Movement area in front of the washbasin at least 150 x 150 cm
- Top edge of washbasin at a height of 80 - 85 cm
- **Clear height under the washbasin 65 cm** (standard min. 70 cm), siphon protected (plastic)
- Accessible width of at least 100 cm; depth corresponds to standard
- Single-lever tap, distance between tap and front edge of washbasin 20 - 35 cm
- Mirror lower edge at max. 95 cm height, operating level of fittings at standard height
- **Waste bin cannot be operated with one hand**
- **No changing table available**
